Land Use Application #1368720 - Nelson Short Plat

TREE INVENTORY/ARBORIST REPORT

8514 Bowdoin Way
Edmonds, WA

PLN2024-0015 - Stormwater Site Plan for Nelson Short Plat, City of Edmonds, WA - 02/22/24 - Preliminary

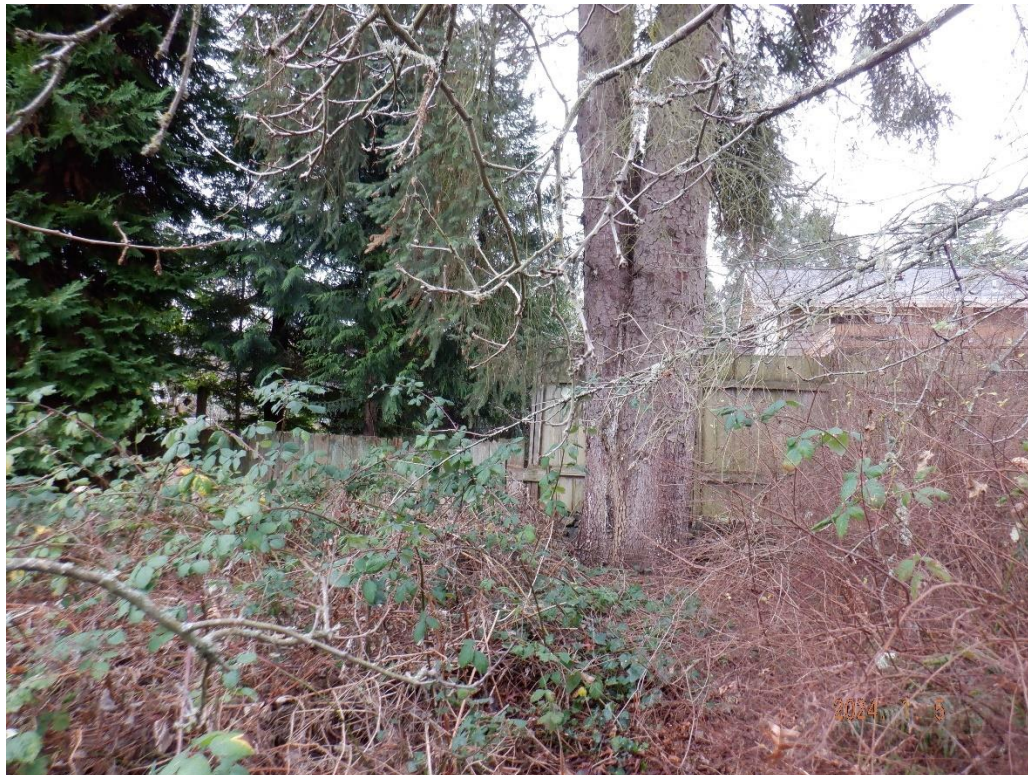
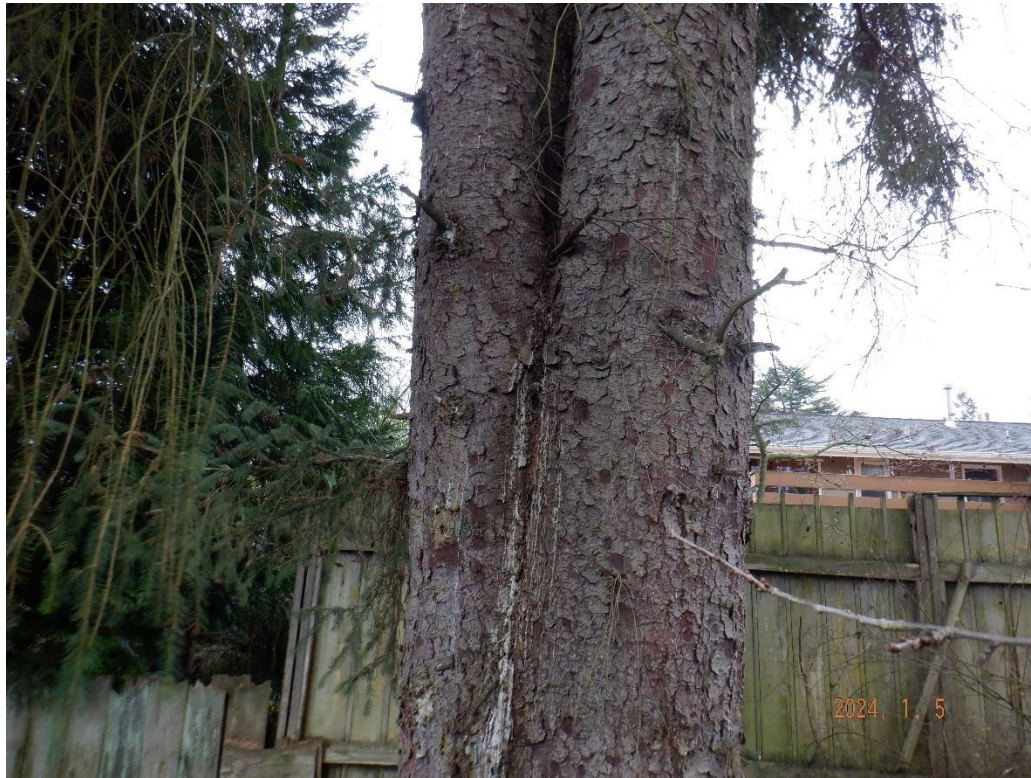
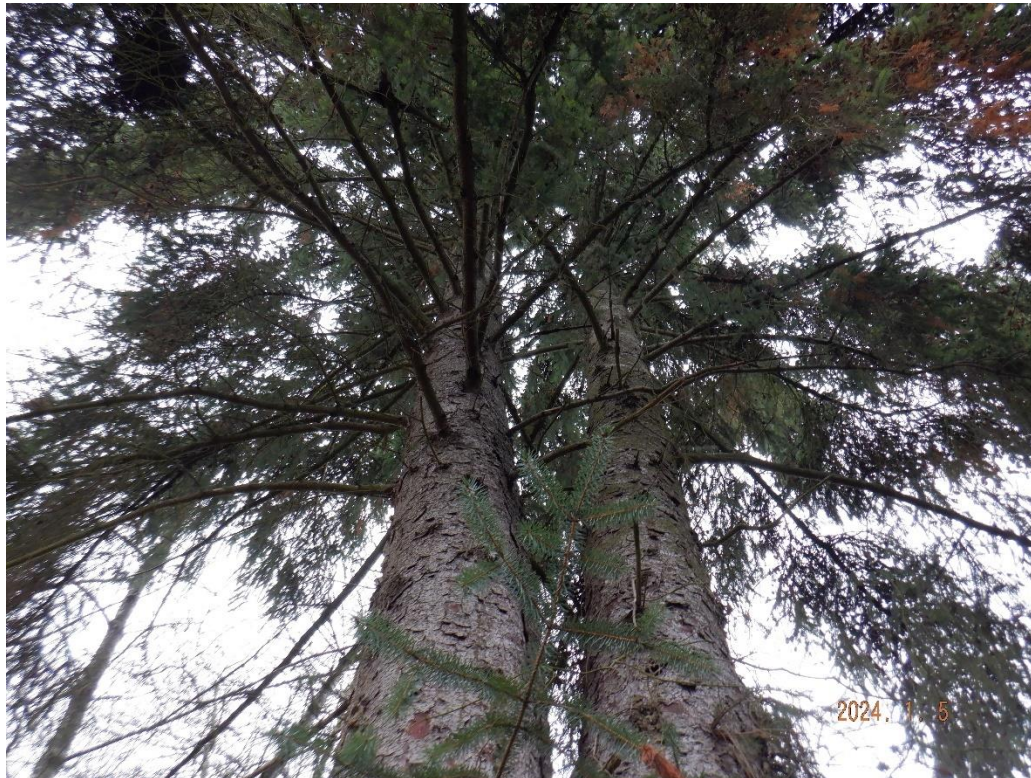
Tree #6 is a semi-mature Sitka spruce. The lower trunk forks at roughly 8-feet above ground into codominant stems or trunks. There is no noteworthy buildup of included or embedded bark between the forked trunks. Stems are upright or vertical with no leans. Vigor is good. Condition is 'good'.

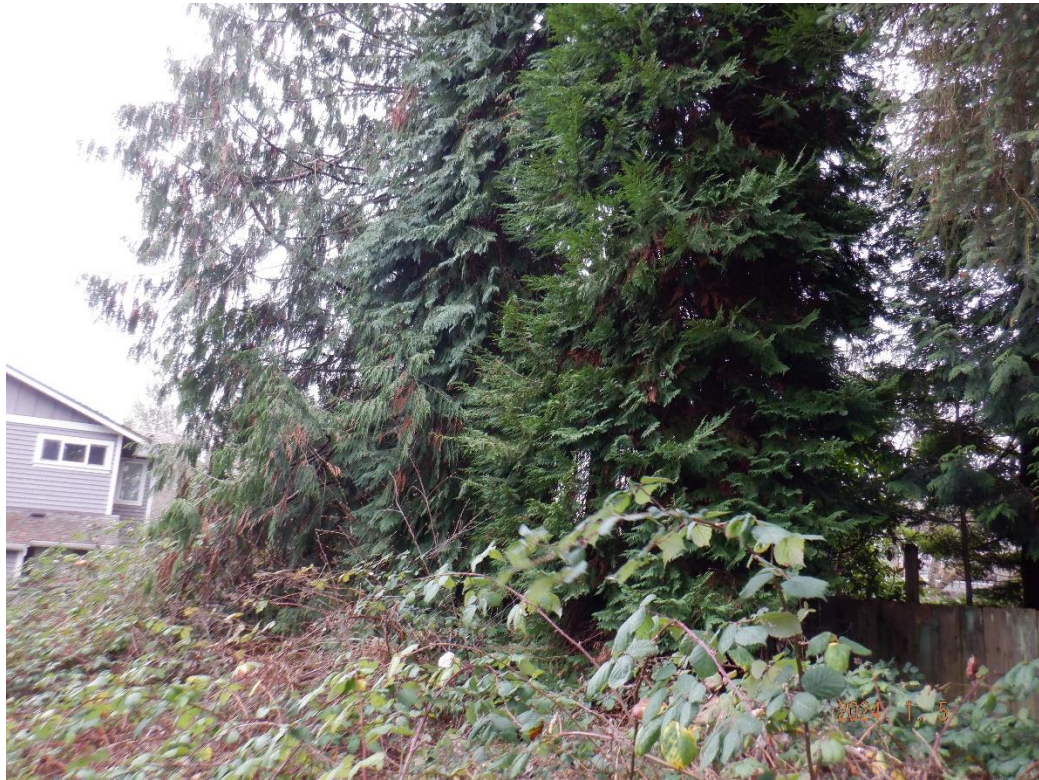
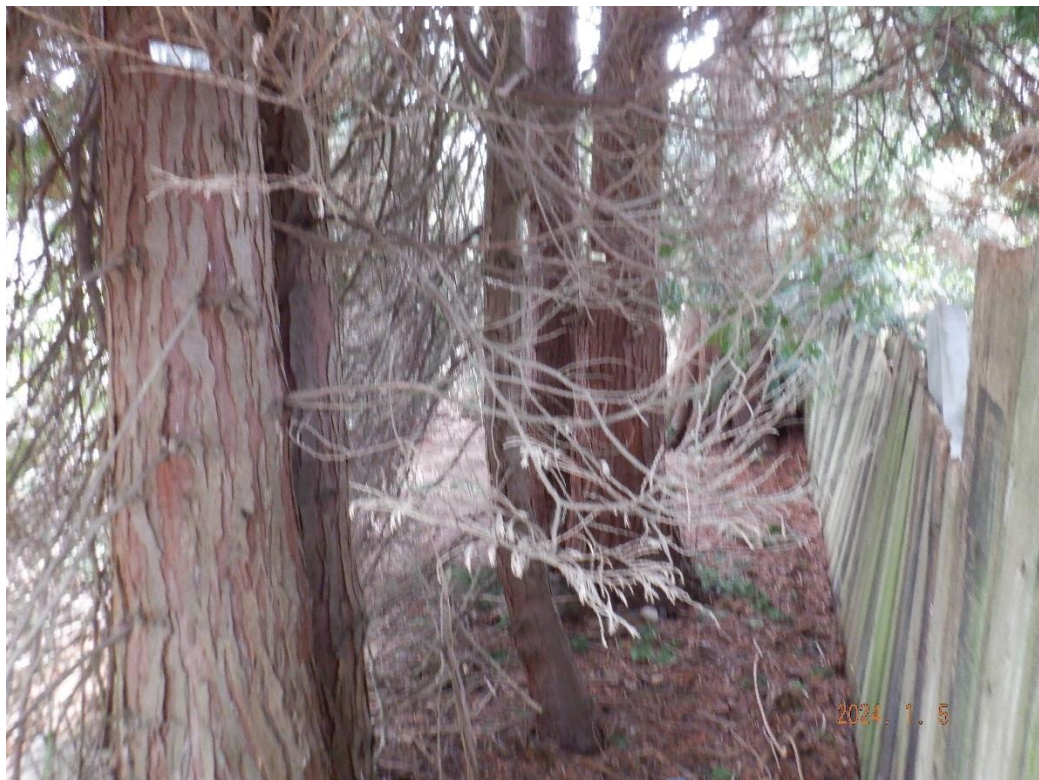
Trees #7, #8 and #9

Trees #7 and #8 are semi-mature Lawson cypress. They have developed typical form for the species and are of good vigor. No concerning issues were observed. Condition is 'good'.

Tree #9 is a semi-mature Western red cedar. It is also comprised of two stems or trunks. One of the forked stems is subdominant. There is no noteworthy buildup of included or embedded bark between the forked trunks. Stems are upright or vertical with no lean. Vigor is fairly good. Condition is 'good'.

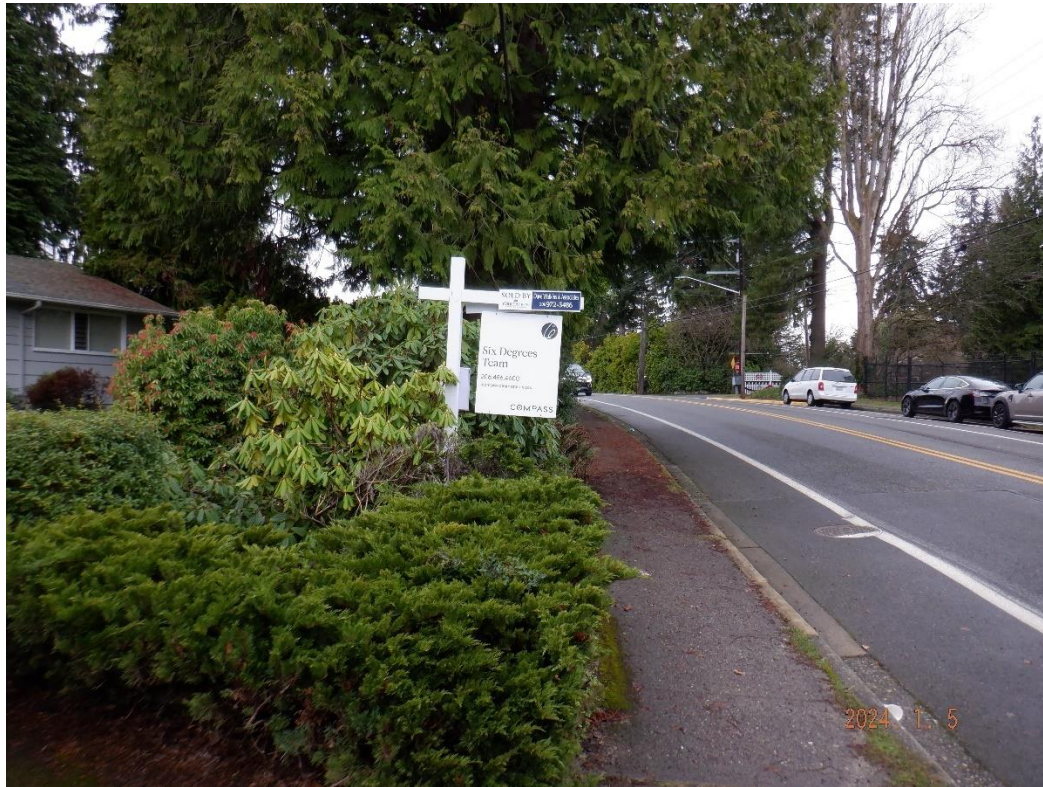
Tree #101 is a semi-mature Western red cedar. This is a large cluster comprised of seven stems or trunks. There is a moderate buildup or accumulation of included or embedded bark and associated seams between some of the forked trunk attachments. Vigor is good. Overall condition is rated as 'good'.

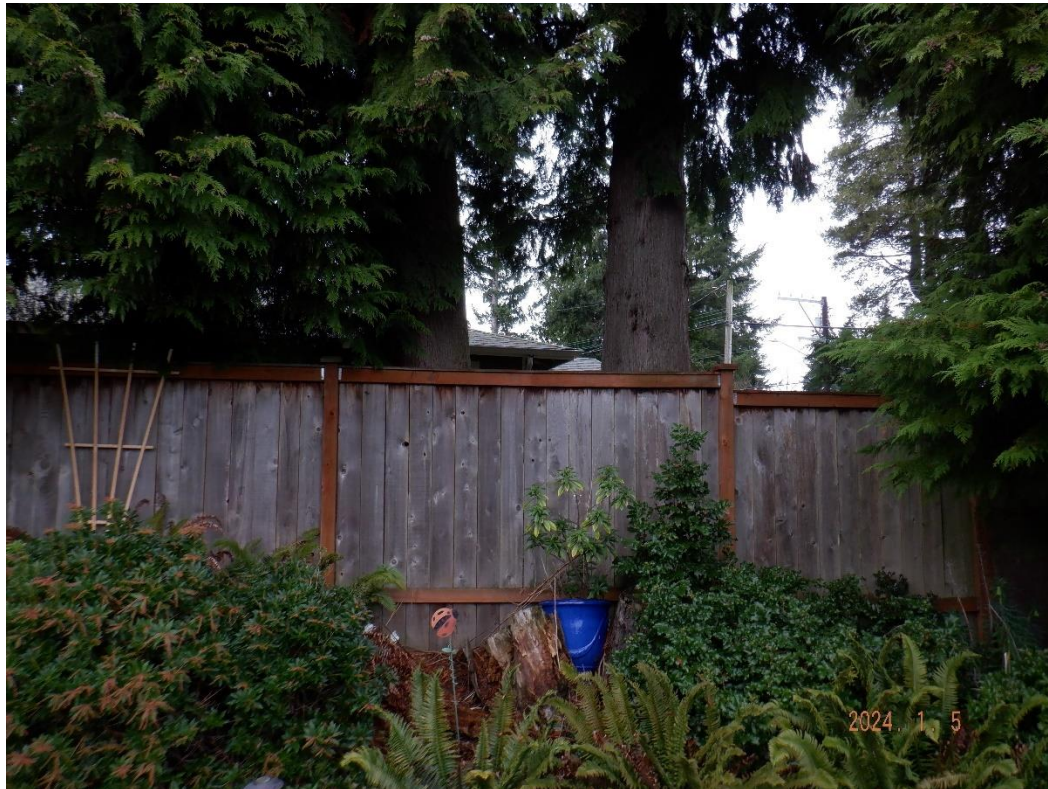
Trees #103 and #104 are semi-mature Western red cedar. No concerning issues were observed from the subject property side. Condition is 'good'.

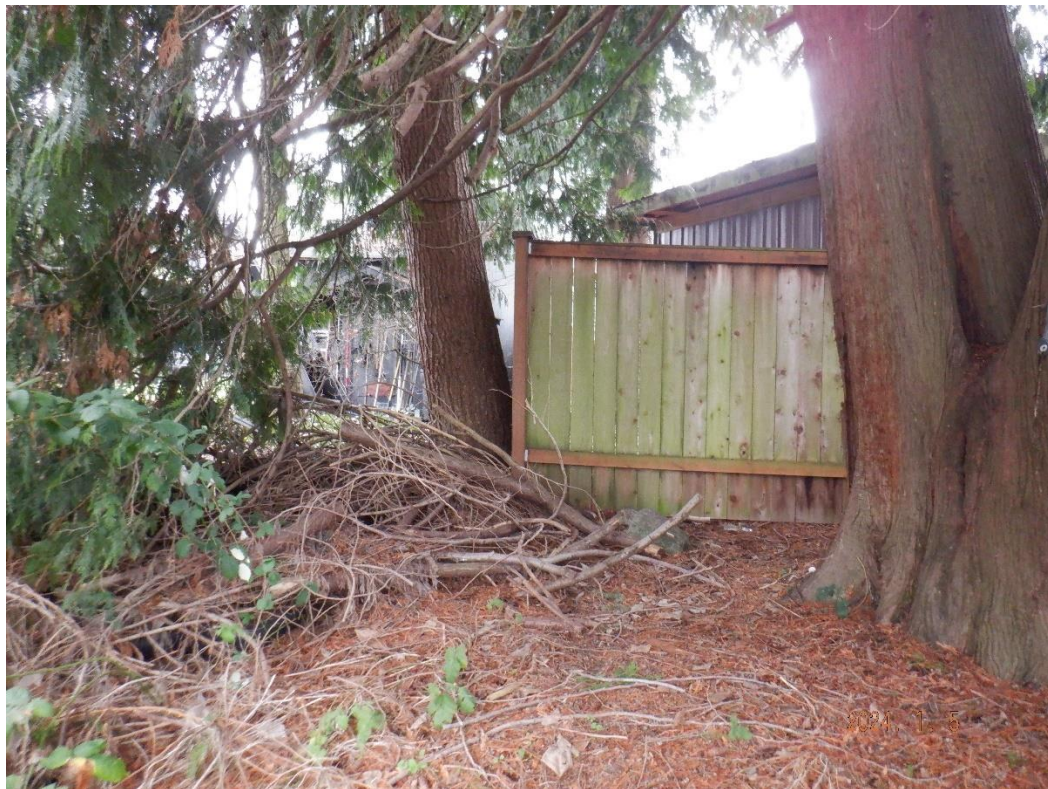
Tree #105, at end of fence

Tree #105 is a young to semi-mature Douglas fir, located close to the west property line. Vigor is good. No concerning issues were observed from the subject property side. Condition is 'good'.

The most noteworthy impacts will be to neighboring Tree #105. The cut for the new foundation will be roughly 5-feet from the property line, inside its dripline and normal limits of disturbance. Severing roots at the foundation cut east of the tree would not be expected to have any adverse impacts on its structural stability. This is a young to semi-mature specimen. This is a hardy species and tolerable of noteworthy impacts. It is expected to remain viable post construction. The project arborist should be on-site to oversee the foundation excavation so any impacted roots can be properly pruned and to minimize overall impacts. The cut stump of Tree #5 shall be grinded down to just below grade to minimize impacts to Tree #105

Any excavation within the driplines of retained trees and/or the neighboring trees shall be monitored by the project arborist so necessary precautions can be taken to minimize overall impacts. Any roots damaged during site work outside of the tree protection area shall be pruned clean at sound tissue prior to backfilling or finishing areas. Sound tissue is where the root is undamaged and the bark is completely intact with the root. This will help roots to seal off potential decay and allow them to sprout new growth. Any disturbed areas near protected trees shall be watered weekly during the dry season of June through September. This will help to create a favorable environment for new root growth and reduce the overall stress associated with root loss and disturbance.
